By John Torsiello info@mainstreetmag.com Photos courtesy of George Lagonia

There is absolutely no way the former owners of what is known as The Hatfield Farm could have imagined the ultimate use for their sheep barn, located in Spencertown, NY. I mean, treadmills, basketball, high definition televisions, thermal paned windows? They weren't even dreamt about in the middle of the 19th century.

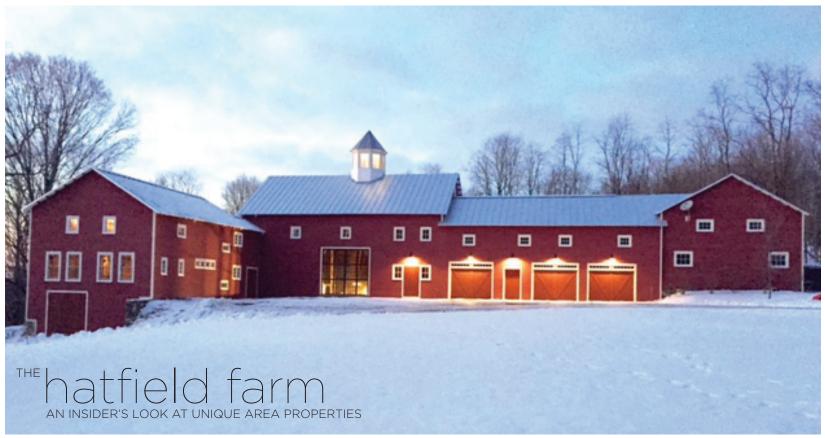
Interestingly, the barn was pictured in the foreground in a painting that served as the cover of an issue of *Columbia County History and Heritage* prepared by the Columbia County Historical Above: The restored historic Hatfield barn at dusk.

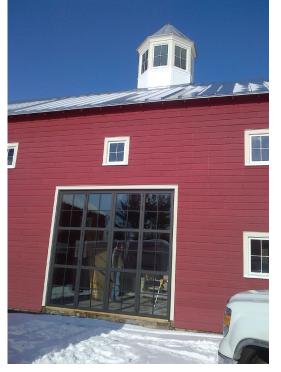
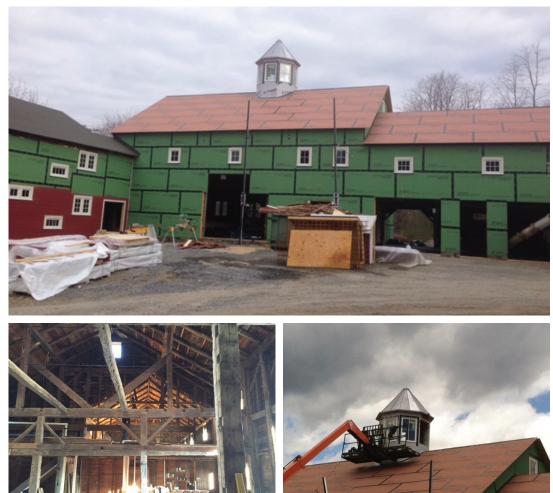
Above, top to bottom, L-R: A work in progress, see photo on previous page for the finished and restored Hatfield barn at dusk. The interior of the barn contains original beams and other wood. The new cupola is placed atop the barn.

This was, of course, no easy task. Mercer said that the biggest challenge was keeping the integrity of the barn's post and beam structure intact, while repairing and supplementing the existing framing with new footings, foundations, and an outer framing "shell" and insulated layer over the post and beam structure. He added, "In order to create new interior spaces, certain existing floor levels were removed to make larger space volumes. Existing roof framing wood timber and log trusses that were hidden by ceiling planks were revealed by removing these boards. All removed wood materials from the barn were carefully preserved and reused throughout the new interior spaces."

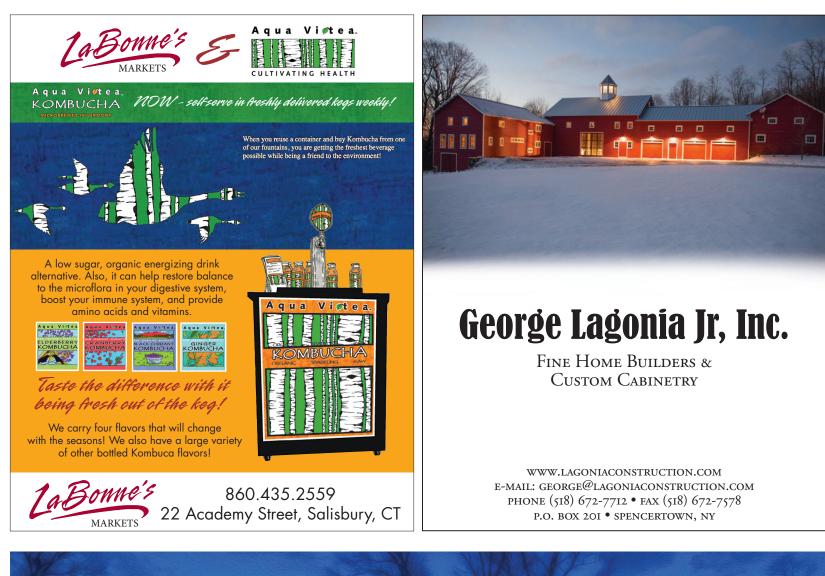
Above: A protective exterior "shell" was built over the existing barn's siding. Left: Folding metal doors, replete with large windows, is the main entryway into the barn. Also depicted in this photo is the finished cupola.

Lagonia explained that, quite remarkably, the entire barn was raised to allow for the creation of a new concrete floor. Also, the entire barn is encased in a new exterior with the original exterior now protected from the elements. Indeed, great care was taken to preserve and restore the existing character of the barn, while adding new design elements, such as a cupola that towers above the barn near its central point, metal roofing and metal folding doors, and to update the exterior and to reflect the new interior uses. All replacement materials match the original siding, trim, and windows. The new replacement concrete foundations are clad with stone veneer to imitate the original stone masonry of the building.
